**ANADROMOUS FISH SURVEYS WITHIN THE
BROOKS EAST CORRIDOR SURVEY AREA, ALASKA**

DOWL HKM
4041 B Street
Anchorage, AK 99503

ABR, Inc.—Environmental Research & Services
P.O. Box 240268
Anchorage, AK 99524

June 2013

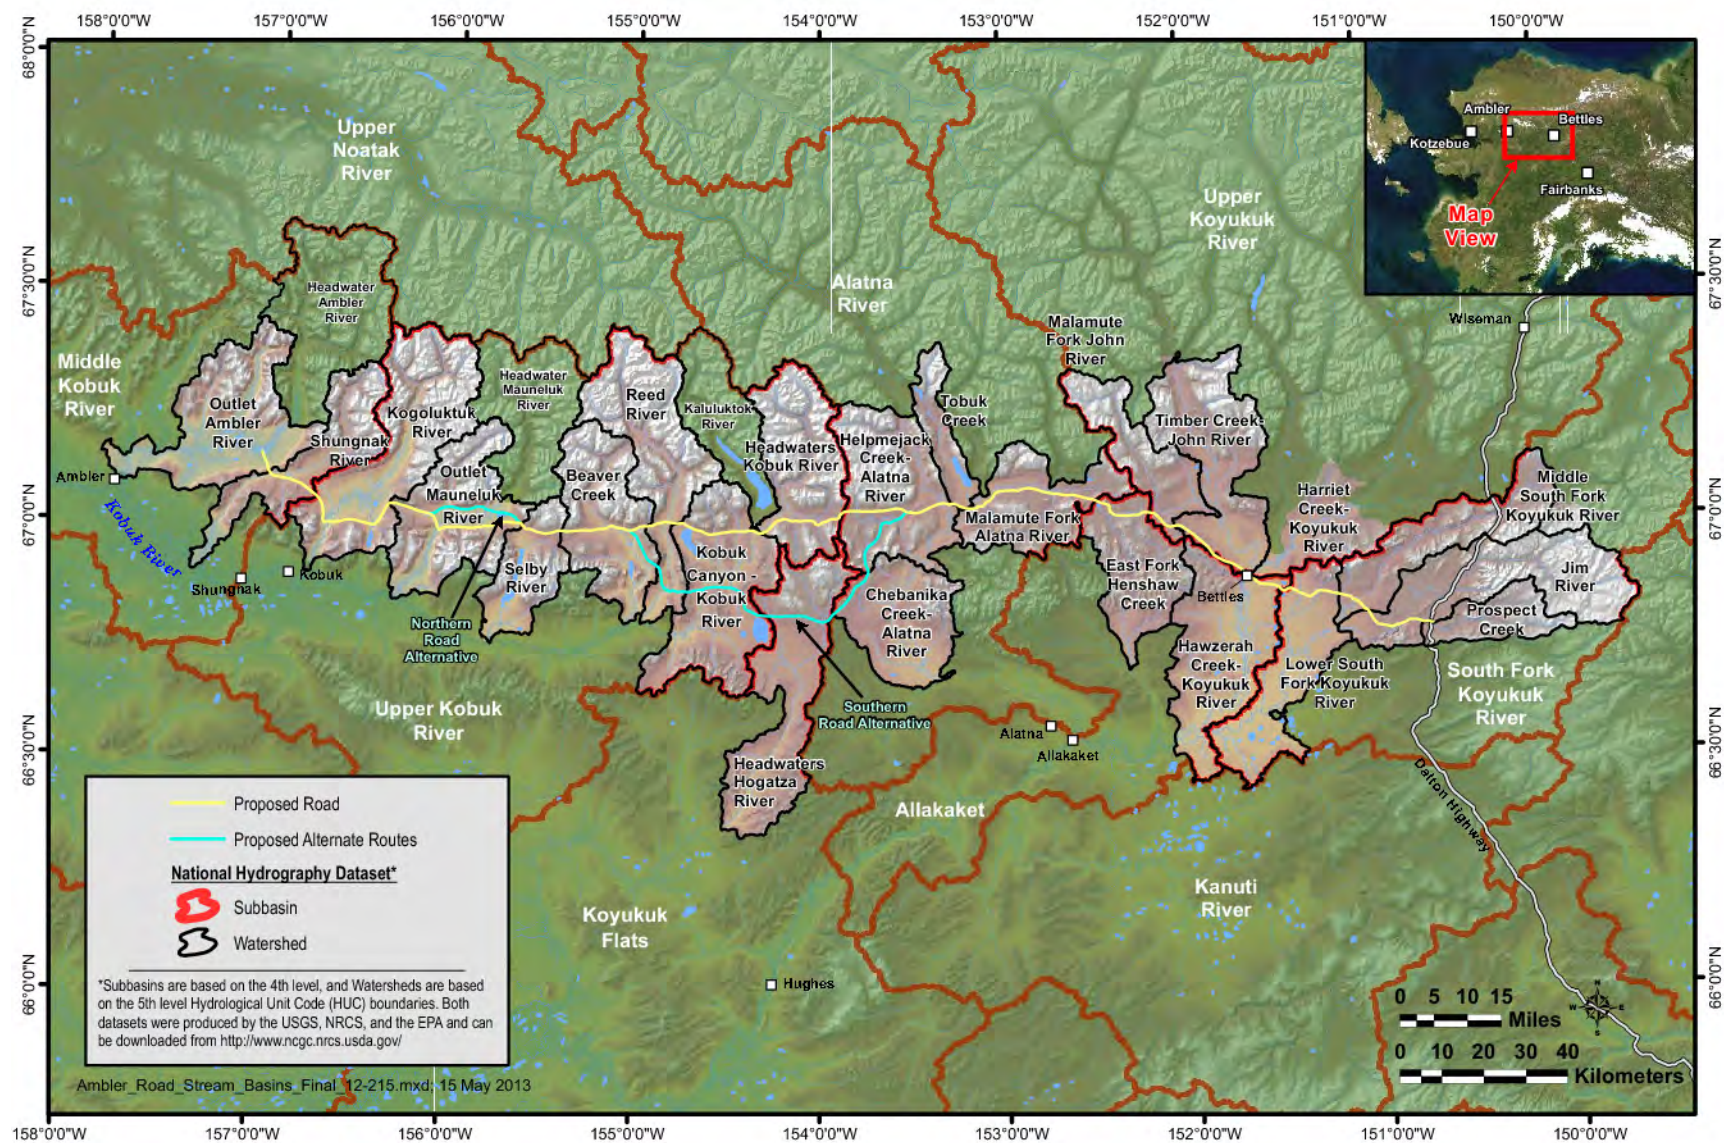
Figure 1. Subbasins and watersheds traversed by the proposed Brooks East Corridor, including the northern and southern options.

The proposed Brooks East Corridor crosses the Outlet Ambler River and Shungnak River watersheds in the Middle Kobuk River subbasin (Figure 1). While sampling did occur in the Shungnak River watershed, no sampling occurred in the Outlet Ambler River watershed. Sampling did occur in the Headwater Ambler River watershed nestled between those two watersheds to the north. Though this watershed is not crossed by the proposed road corridor, its waters are accessible to fish moving throughout all three watersheds. Previous AWC survey work found Chum Salmon, Dolly Varden and undifferentiated whitefish at locations on the Ambler River and its tributary, the Redstone River (Figures 4 and 8). No Pacific Salmon were observed at survey reaches associated with this subbasin during 2012 surveys. However, Dolly Varden were observed well upstream of crossing 0 on Ulaneak Creek (UL01) in the Headwater Ambler River watershed, an extension of the range recorded for Dolly Varden by the AFFI of 8 km (Table 3; Figure 5).

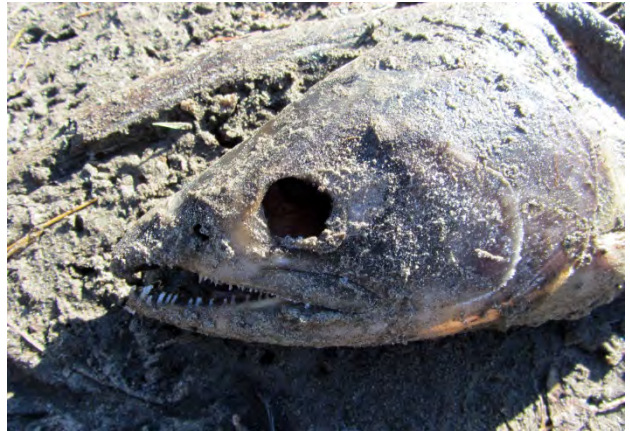
Plate 2. Unidentified salmon carcass observed on a gravel point bar on Beaver Creek, Alaska, September 2012.

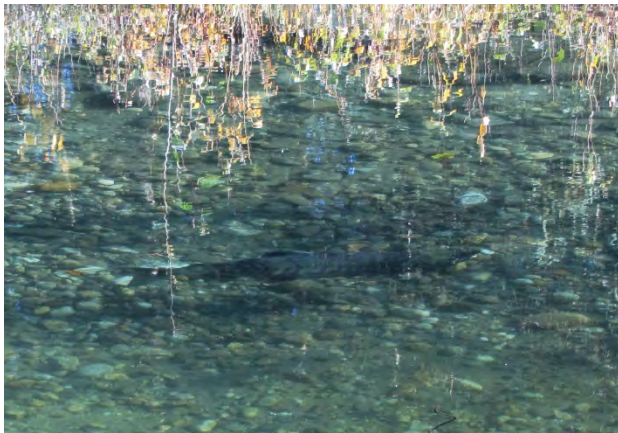
Plate 3. Chum salmon spawning area documented within the Reed River, Alaska, July 2012.

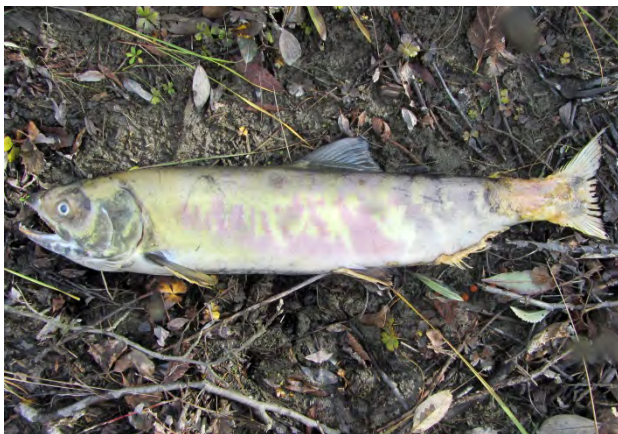
Plate 5. Female chum salmon carcass observed near a spawning area in the Kobuk River, Alaska, September 2012.

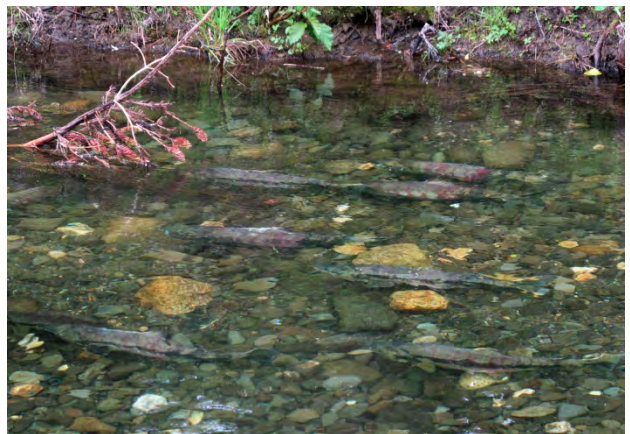
Plate 6. Chum salmon spawning area documented within the Hogatza River, Alaska, July 2012.

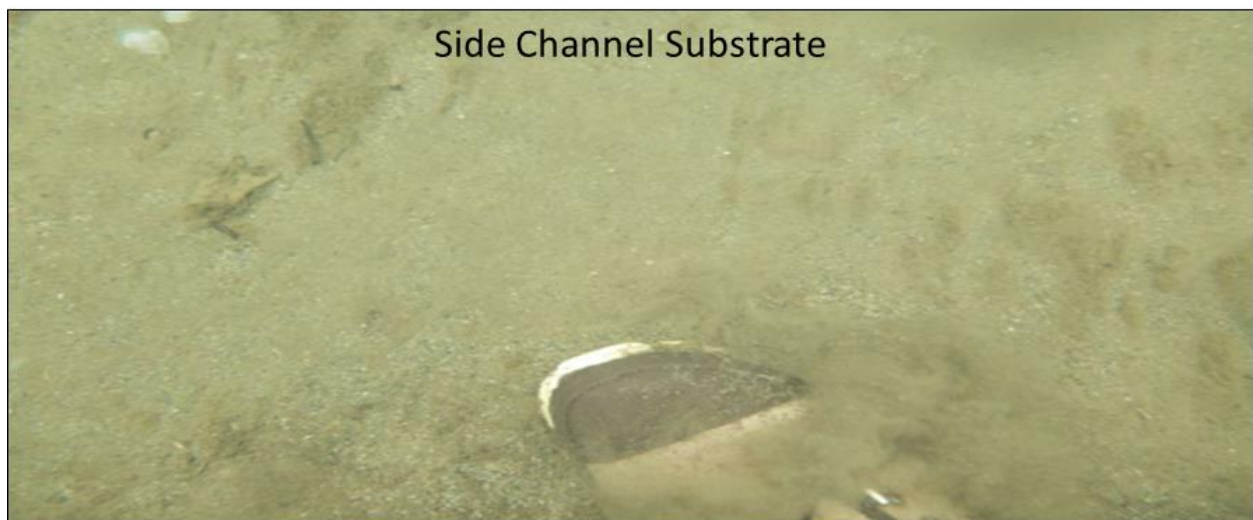
Plate 5. Stream channel characteristics, riparian habitat, and instream substrate composition of side-channel habitat at KG-T1-13, Kogoluktuk River, Brooks East Corridor, Alaska, August 2013.

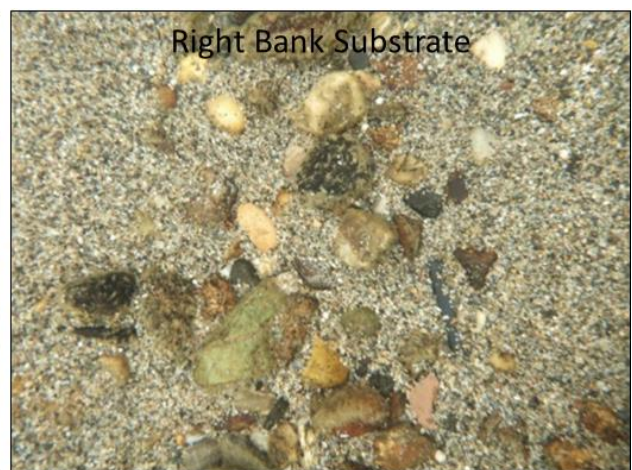
Plate 6. Stream channel characteristics, riparian habitat, and instream substrate composition at transect KG-T2-13, Kogoluktuk River, Brooks East Corridor, Alaska, August 2013.

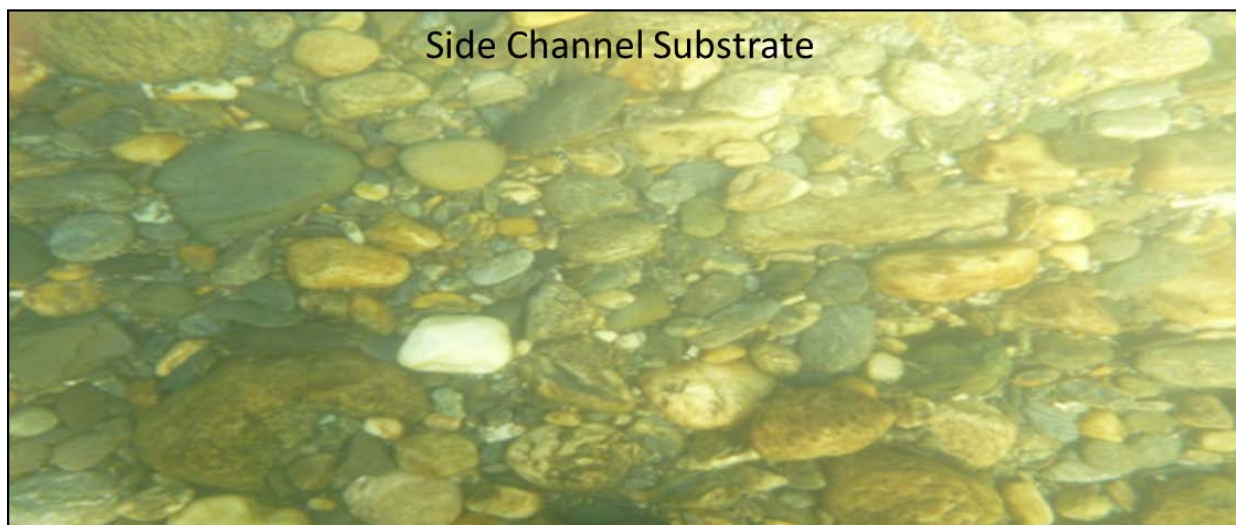
Plate 7. Stream channel characteristics, riparian habitat, and instream substrate composition at partial transect (MN-T1-13) on the Mauneluk River, Brooks East Corridor, Alaska, August 2013.

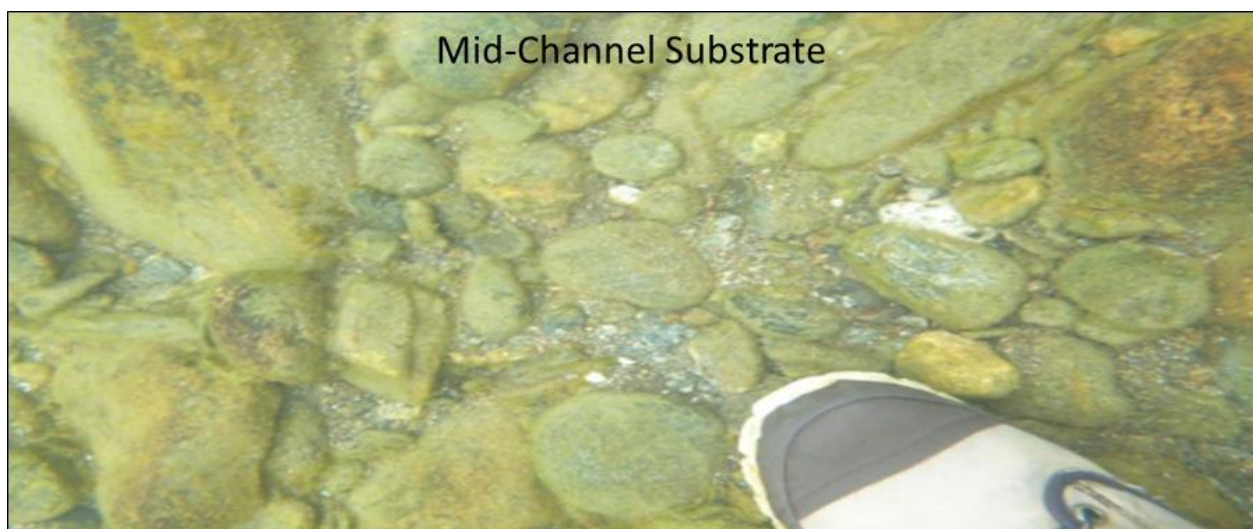
Plate 9. Stream channel characteristics, riparian habitat, and instream substrate composition at transect BV-T1-13, Beaver Creek, Brooks East Corridor, Alaska, August 2013.

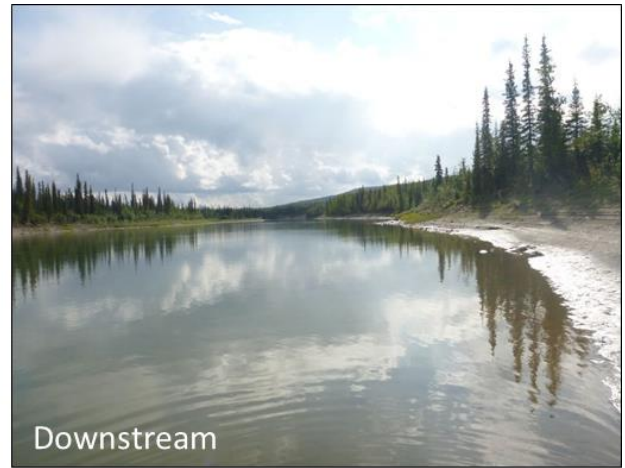
Plate 14. Stream channel characteristics and riparian habitat at observation point AL-T1-13 on the Alatna River, Brooks East Corridor, Alaska, August 2013.

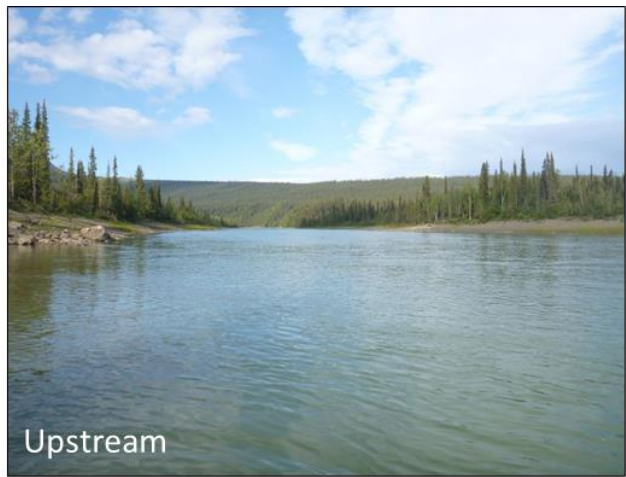
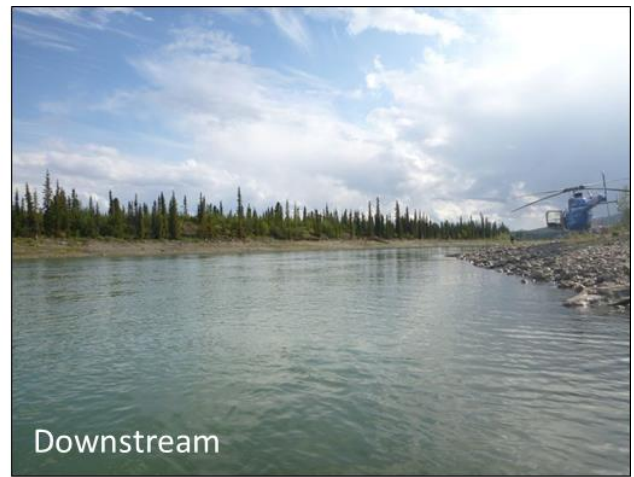
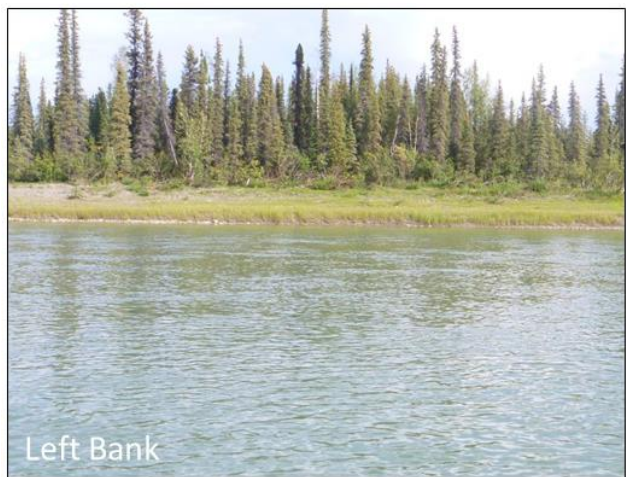
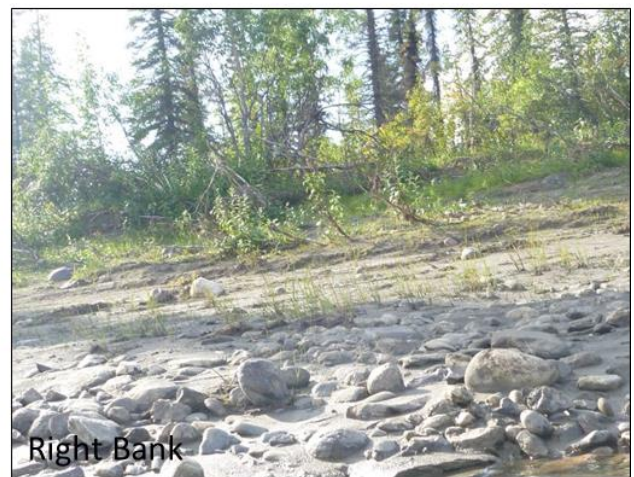
Plate 15. Stream channel characteristics and riparian habitat at observation point AL-T2-13, Alatna River, Brooks East Corridor, Alaska, August 2013.

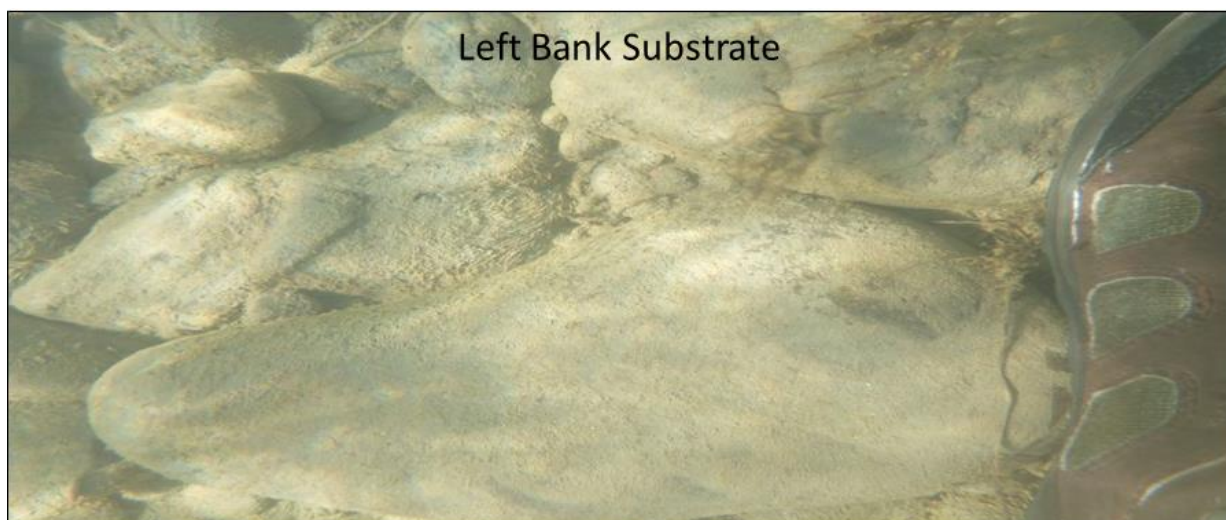
Plate 19. Stream channel characteristics, riparian habitat, and instream substrate composition at observation points on the Koyukuk River, Brooks East Corridor, Alaska, August 2013.

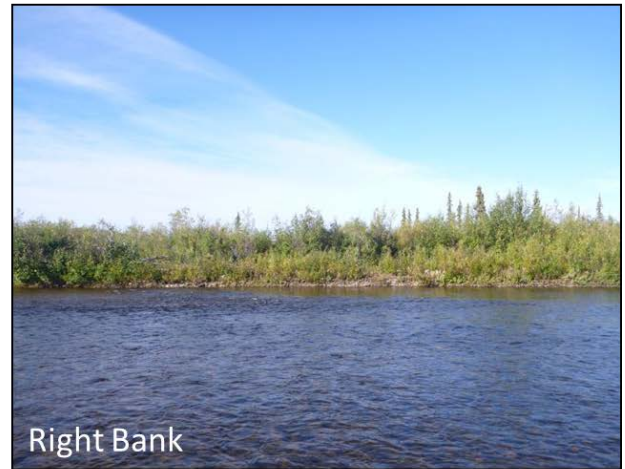
Plate 23. Stream channel characteristics and riparian habitat at upstream observation points on the Jim River, Brooks East Corridor, Alaska, August 2013.

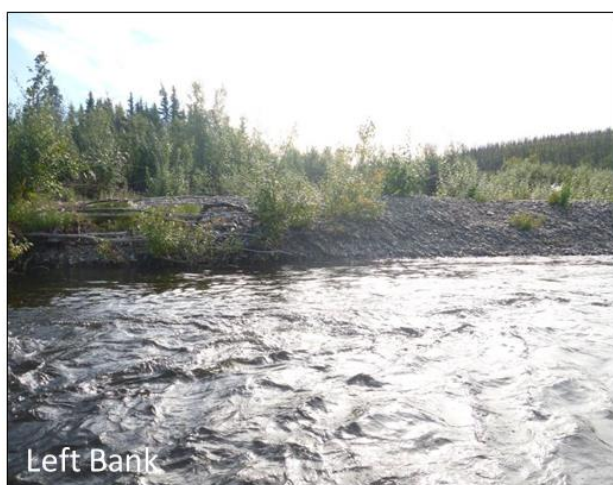
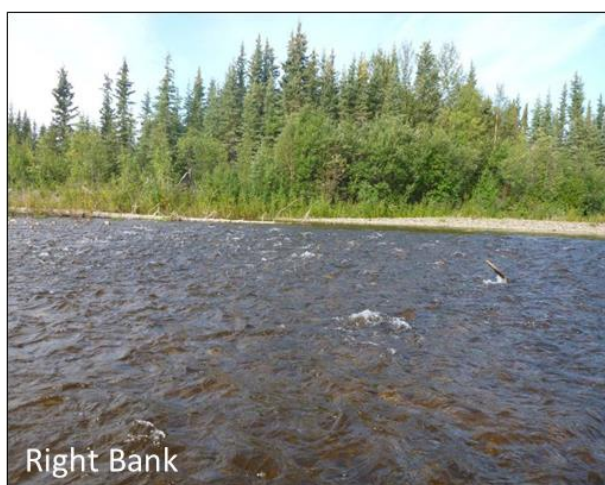
Plate 24. Stream channel characteristics and riparian habitat at downstream observation points on the Jim River, Brooks East Corridor, Alaska, August 2013.

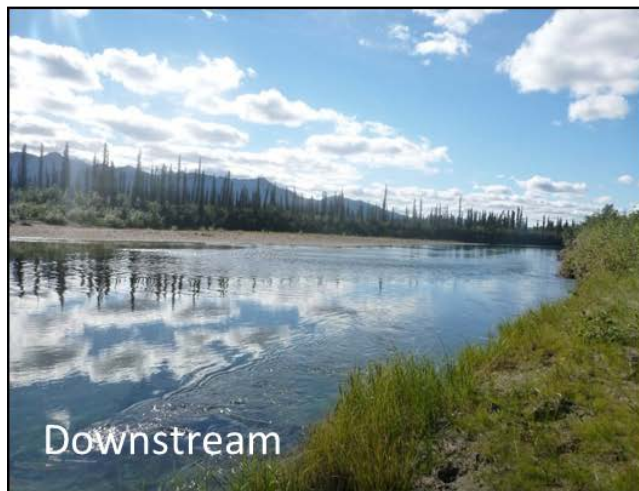
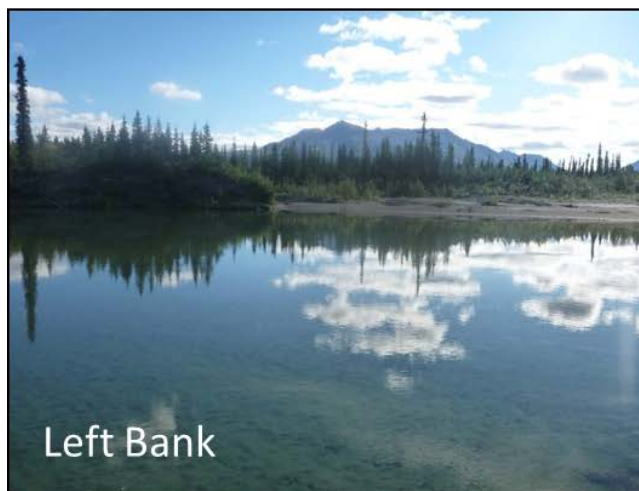
Plate 27. Stream channel characteristics and riparian habitat at observations points on the Mauneluk River (northern option), Brooks East Corridor, Alaska, August 2013.

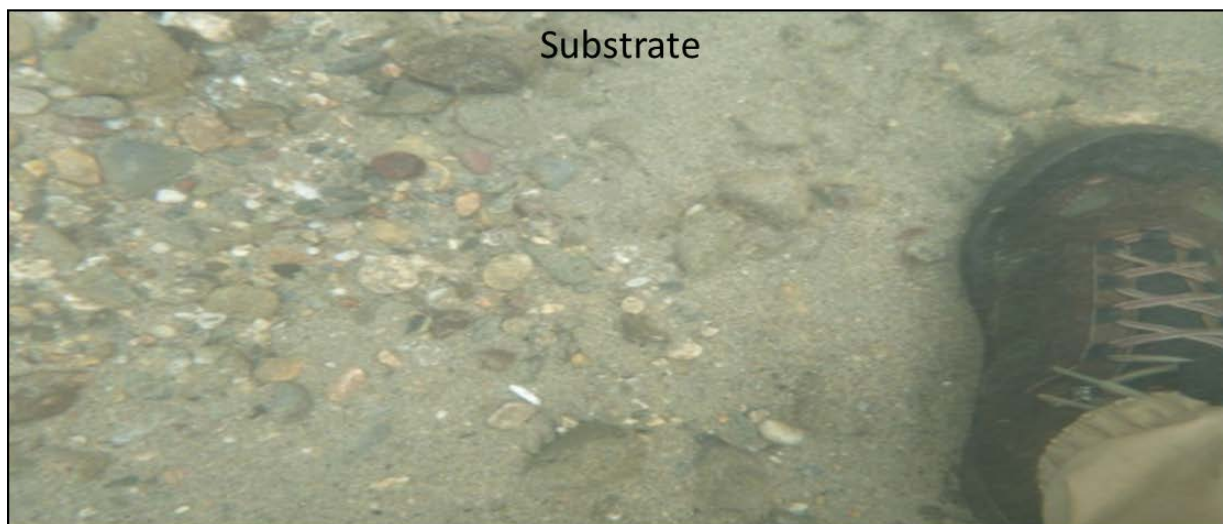
Plate 30. Stream channel characteristics, riparian habitat, and instream substrate composition of side-channel habitat at transect RD-T2-13s, Reed River (southern option), Brooks East Corridor, Alaska, August 2013.

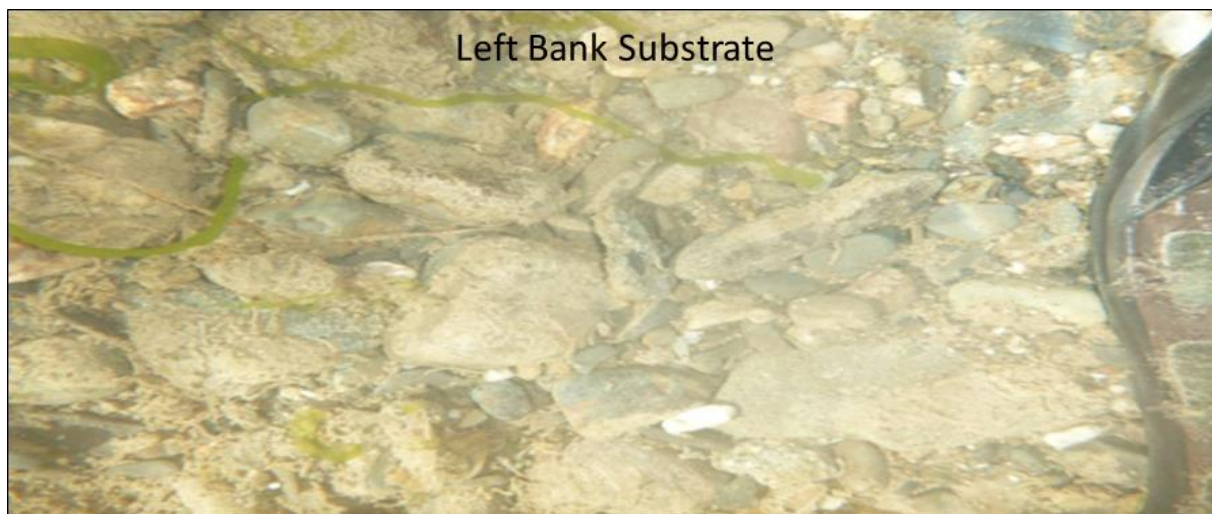
Plate 34. Stream channel characteristics, riparian habitat, and instream substrate composition at transect HG-T2-13SCs, Hogatza River (southern option), Brooks East Corridor, Alaska, August 2013.

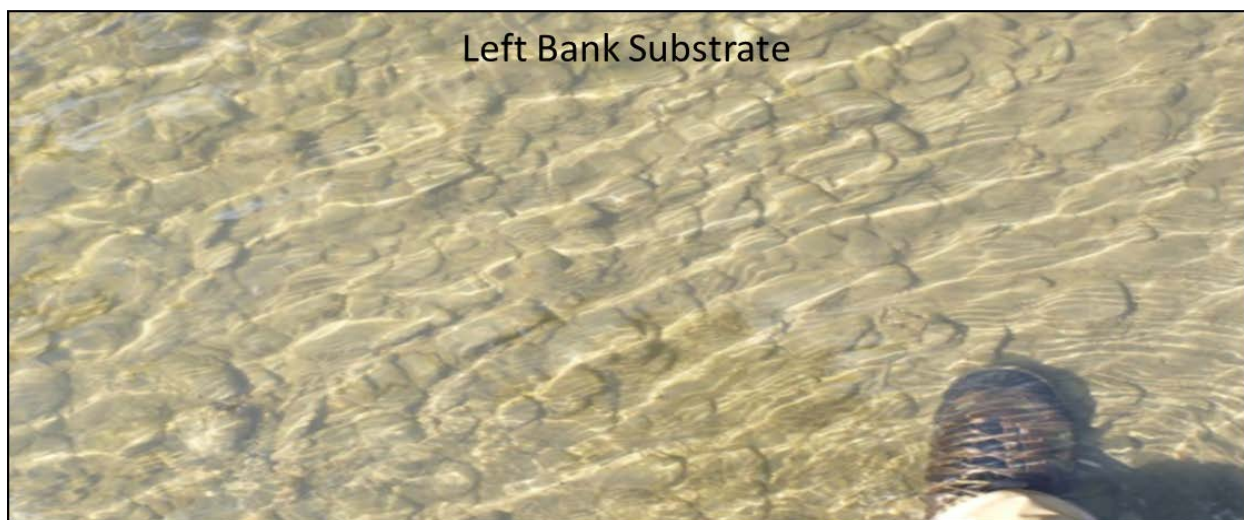
Plate 35. Stream channel characteristics, riparian habitat, and instream substrate composition at transect HJ-T1-13s, Helpmejack Creek (southern option), Brooks East Corridor, Alaska, August 2013.

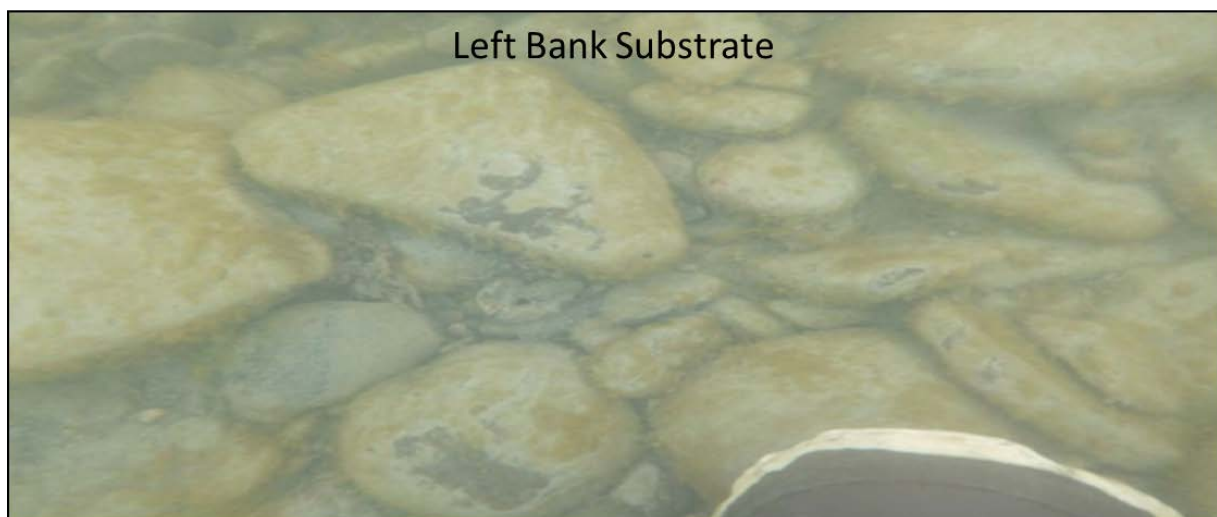
Plate 36. Stream channel characteristics, riparian habitat, and instream substrate composition at transect HJ-T2-13s, Helpmejack Creek (southern option), Brooks East Corridor, Alaska, August 2013.

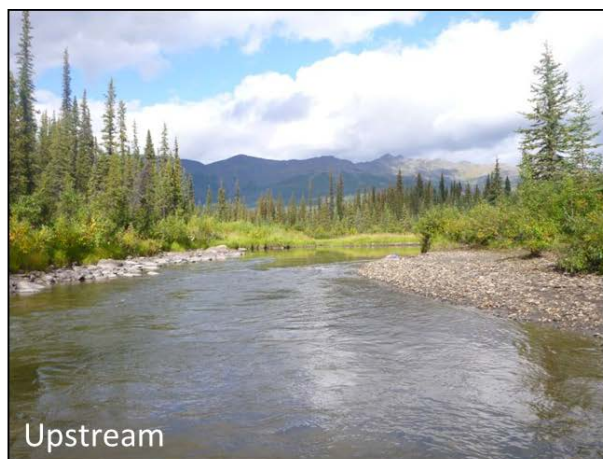
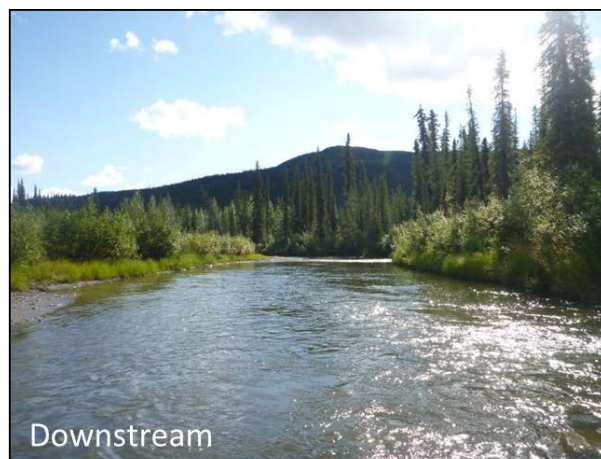
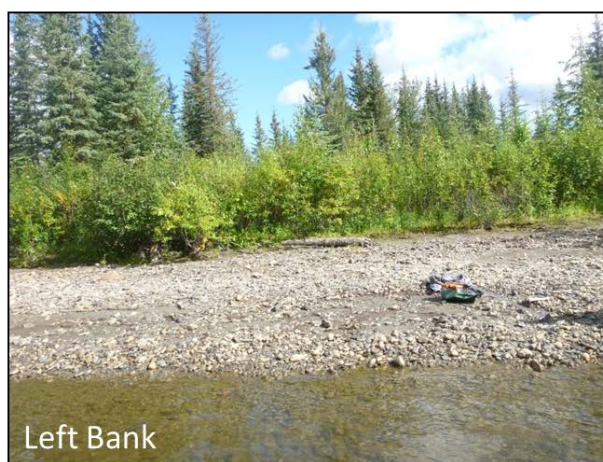
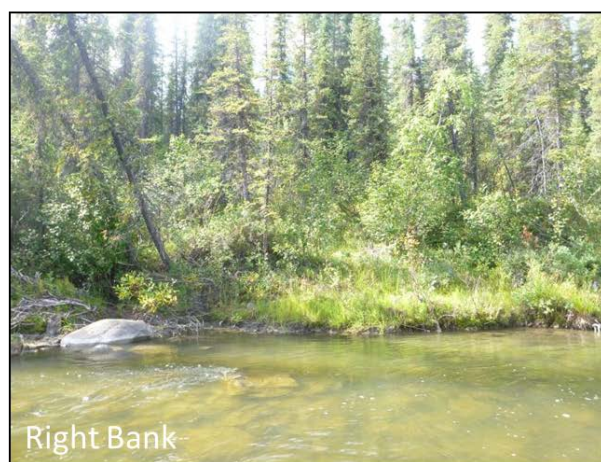
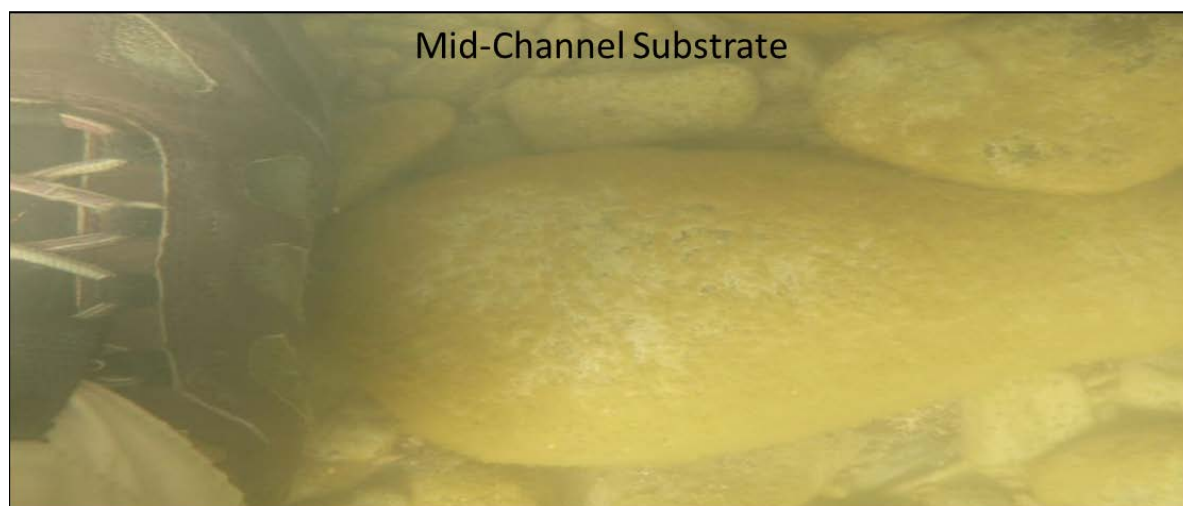
Plate 38. Stream channel characteristics, riparian habitat, and instream substrate composition at 3 observation points on Helpmejack Creek, Brooks East Corridor, Alaska, August 2013.
